## Images in Clinical Rheumatology

### Metallosis as a Cause of Pain and Inflammation in a Patient With a Knee Replacement: A Case Description<sup>☆</sup>

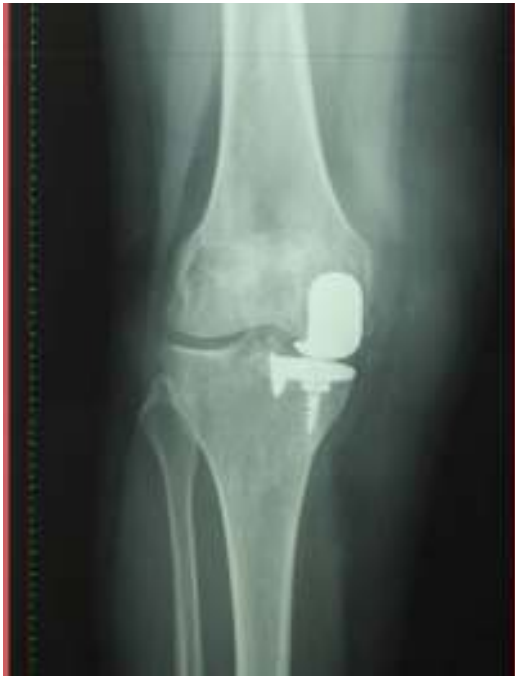
**Fig. 1.** Anteroposterior radiograph of right knee showing the unicompartmental prosthesis.

A 72-year-old woman who had undergone unicompartmental arthroplasty in right knee 12 years earlier, presented with a 6-month history of pain in that knee, in the absence of fever or systemic symptoms. On physical examination, the knee was found to be swollen. Radiography revealed a prosthesis in the medial compartment, which remained unchanged since the partial knee replacement (Fig. 1). Arthrocentesis yielded a dark fluid (Fig. 2) with 150 white blood cells/ $\mu$ L (75% polymorphonuclear cells), glucose level at 90 mg/dL and proteins at 2 mg/dL. Culture of the joint fluid was negative. With the suspicion of metallosis, the patient was referred to the orthopedics department and underwent total knee replacement. The pathological study of a specimen of synovial tissue showed macrophages with a blackish pigment in the cytoplasm and lymphocytes (Figs. 3 and 4). At the present time, the patient is asymptomatic.

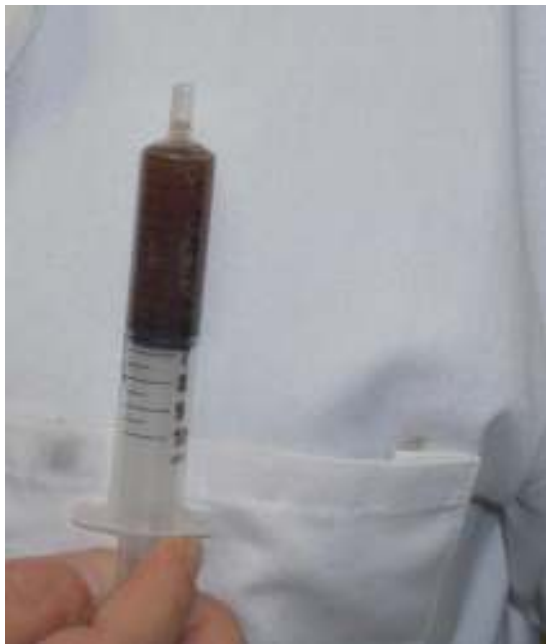
**Fig. 2.** Joint fluid obtained during arthrocentesis.
